**BMP EFFECTIVENESS REPORT
18-9001-15
FAIRBANKS, ALASKA**

February 2006

Submitted To:
Alaska Department of Environmental Conservation
Water Quality Program
610 University Avenue
Fairbanks, Alaska 99709

By:
Shannon & Wilson, Inc.
2355 Hill Road
Fairbanks, Alaska 99709-5326

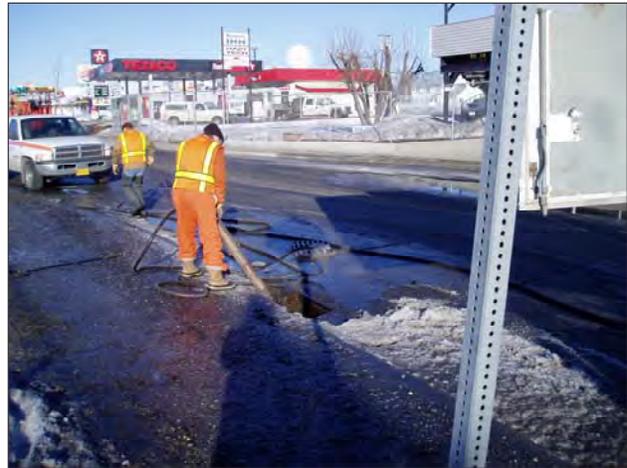
ADOT&PF personnel thawing stormwater system inlet during 2005 breakup

may remain frozen after most surface water has thawed because of the insulation afforded by the ground. Many storm inlet catch basins require steam thawing to deal with the local flooding, which may include several thousand gallons of water. This thawing may result in a peak discharge of sediment and pollutant laden water to the receiving water body. However, we were not able to identify storm outlet discharges as a function of steam thawing. Significant maintenance costs are incurred thawing the pipes in the spring.
